Documenting the Changing Floodplain of Nileas Basin in North Euboea (Greece) before and after Storms Daniel and Elias

Keywords: Hydraulics; On-site inspections; Floods; Plane trees disease; Wildfires

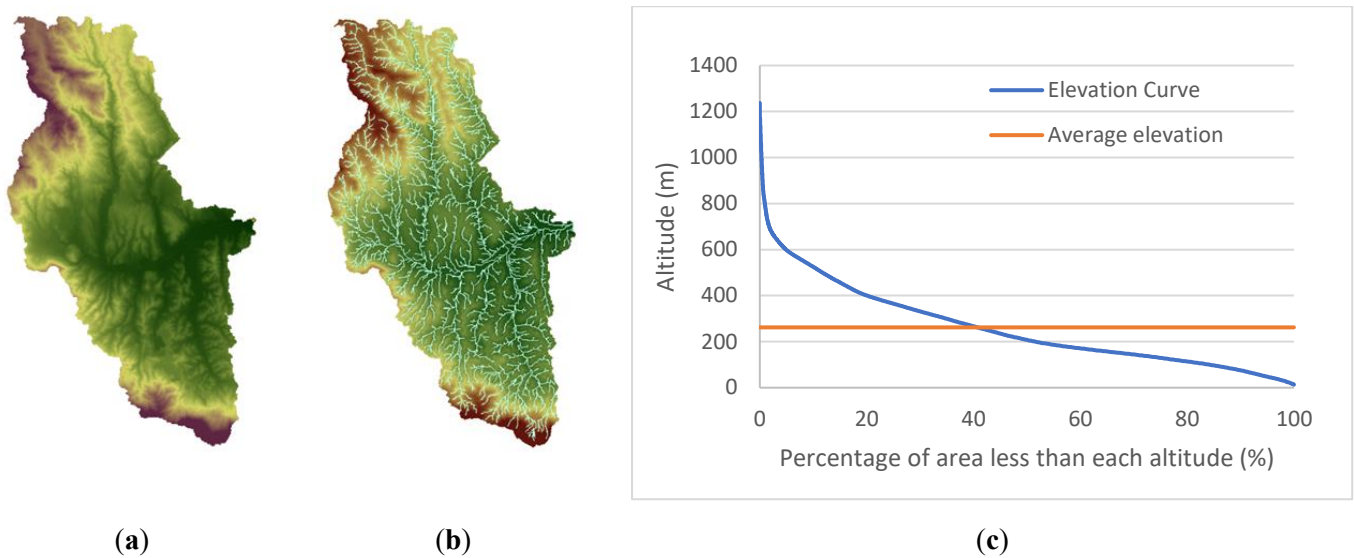
Figure 3. (a) The river basin of Nileas River; (b) hydrographical network (c) elevation curve.

The morphological characteristics of the basin area of Nileas River (Figure 3) are summarized in Table 1 and are mainly derived from Digital Elevation Model and national databases. The river basin of Nileas River provides an overview of the geographical study area, since all hydrological processes occur inside the river basin's boundaries. The hydrographical network illustrates the detailed river network within the Nileas River basin, including main rivers and tributaries, which is essential for analyzing how water flows and accurate flood modelling. Also, the river connectivity influences the distribution and health of flora in the riverbeds.

Both river basin and hydrographic network are derived from Digital Elevation Model following GIS procedures and then cross-checked with national geodatabases [11], The elevation curve depicts the distribution of elevations inside the Nileas River basin, which is crucial for comprehending how variations in topography influence microclimate, water flow dynamics, and, subsequently, the ecological conditions, the plant communities, and flood risks throughout the basin. Part of the land is cultivated by the locals [12].

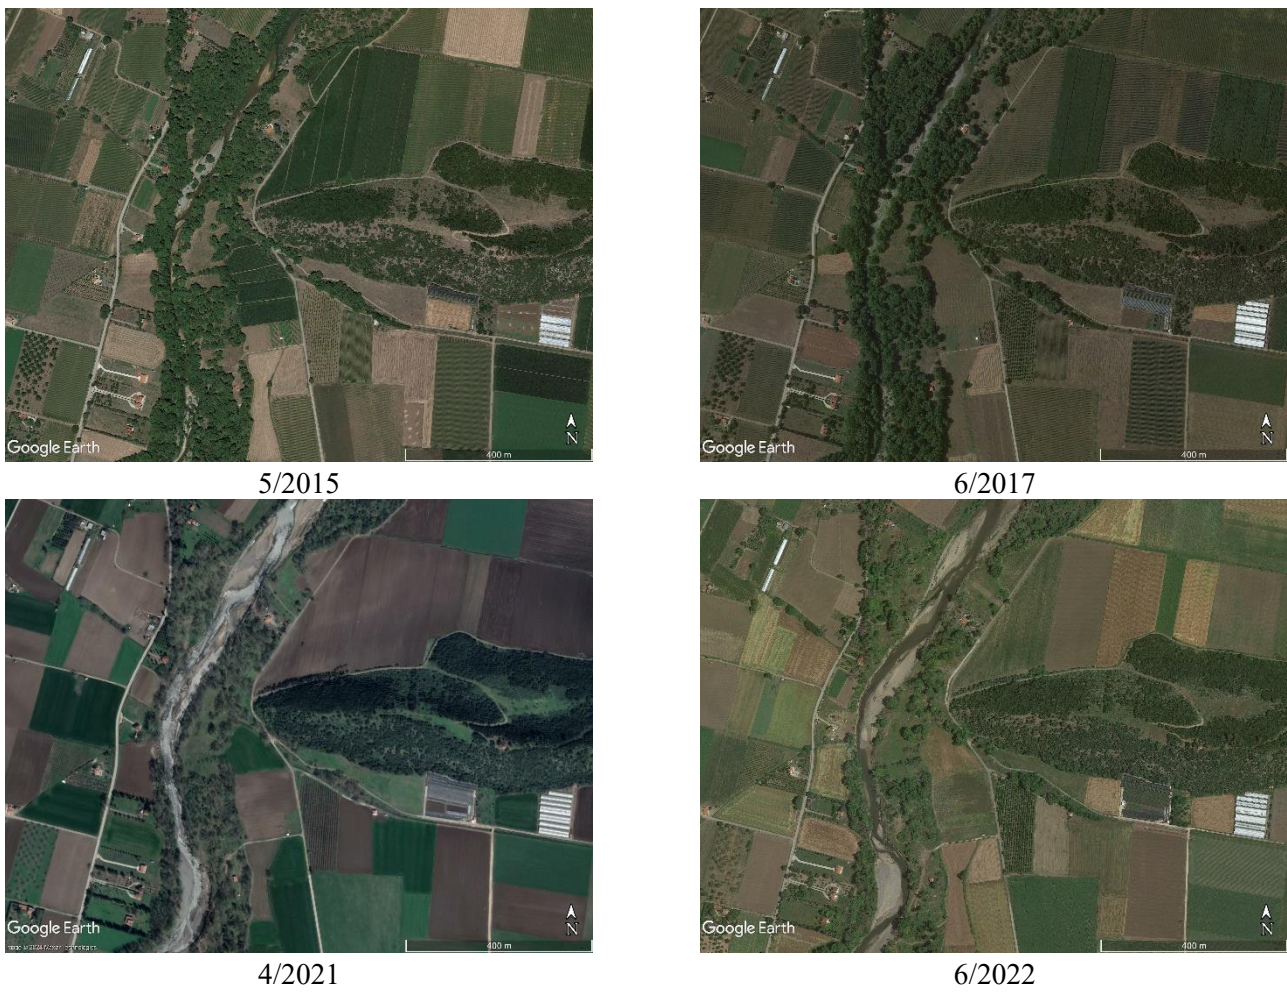
Figure 4. The evolution of the disease in plane trees.

The evolution of the disease in plane trees is depicted in Figures 4 and 5 and more analytically in sections 1 and 2 of the supplementary material in which is presented a detailed study on the evolution of flora in the riverbed of the

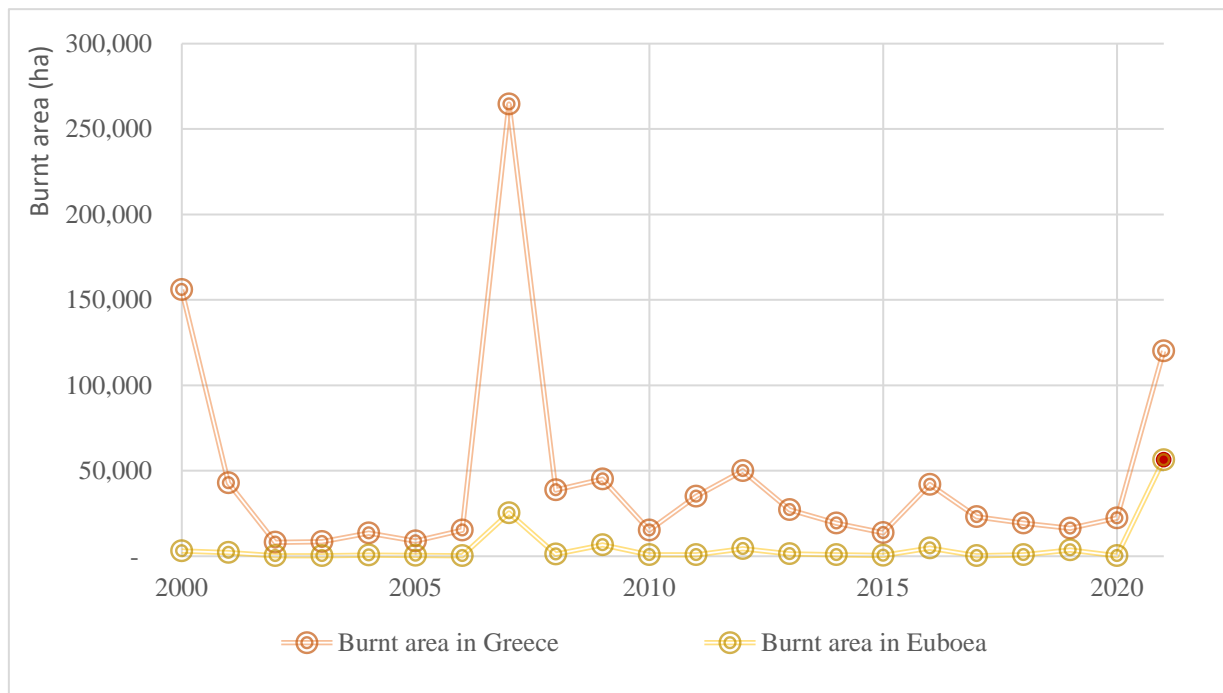
Figure 6. The evolution of wildfires in Greece and Euboea (2000–2021) [7,16].

huge clusters [14] to easily act as abundant fuel material with the potential to produce megafires. This is verified by the fact that megafires in Euboea have recorded in 1977, 2007 and in 2021 [15] (Figure 6).

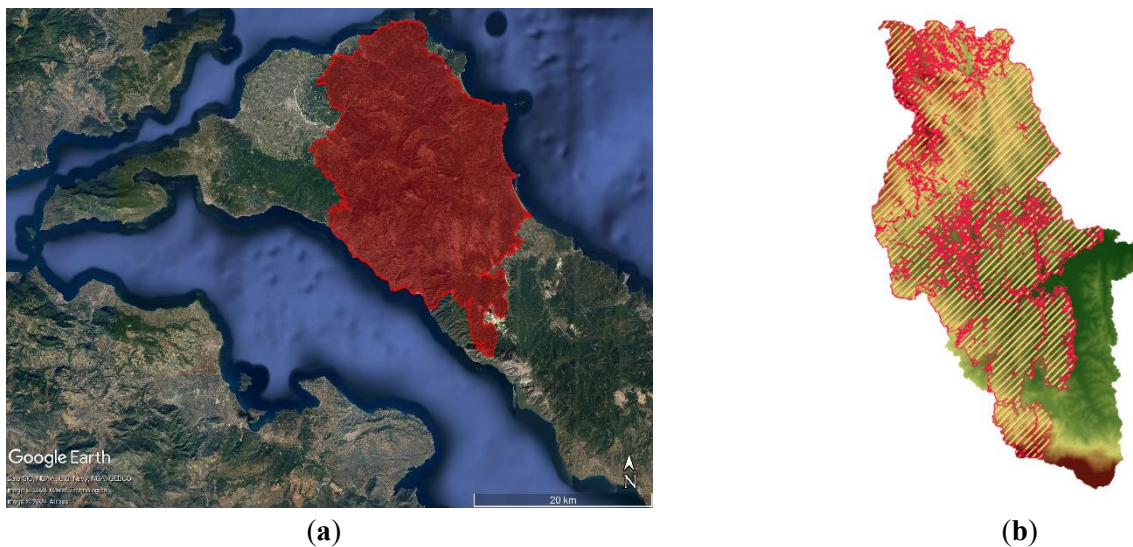
Figure 7. (a) The area of wildfire in 2021 (source [10,16] after adaptation); (b) The burned area in river basin of Nileas River [17].

In total, an area of 125.48 km² was burned, while in the Nileas’ River basin, 68% of the total area was affected by the fire, impacting river flow and flood patterns (Figures 7b and 8).

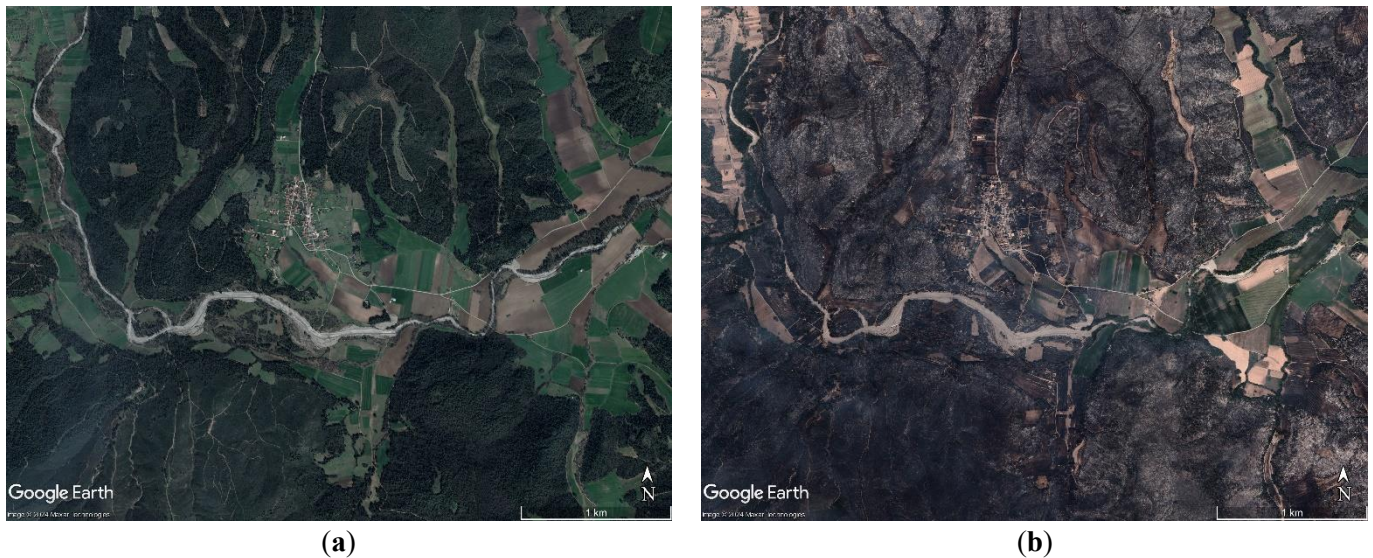
Figure 8. A part of the basin of Nileas River (a) before the wildfire (April 2021), and (b) after the wildfire (August 2021) (source [10] after adaptation; more analytical view in section 3 of the supplementary material).

The effects of the 2021 wildfire, which occurred in North Euboea (Figure 7a), resulted in the decrease of the interception, increase in runoff, altered soil characteristics and roughness, and increase in stormflow volume and peak flow. In addition, other significant increases were noted, influenced by the fire intensity and watershed features.

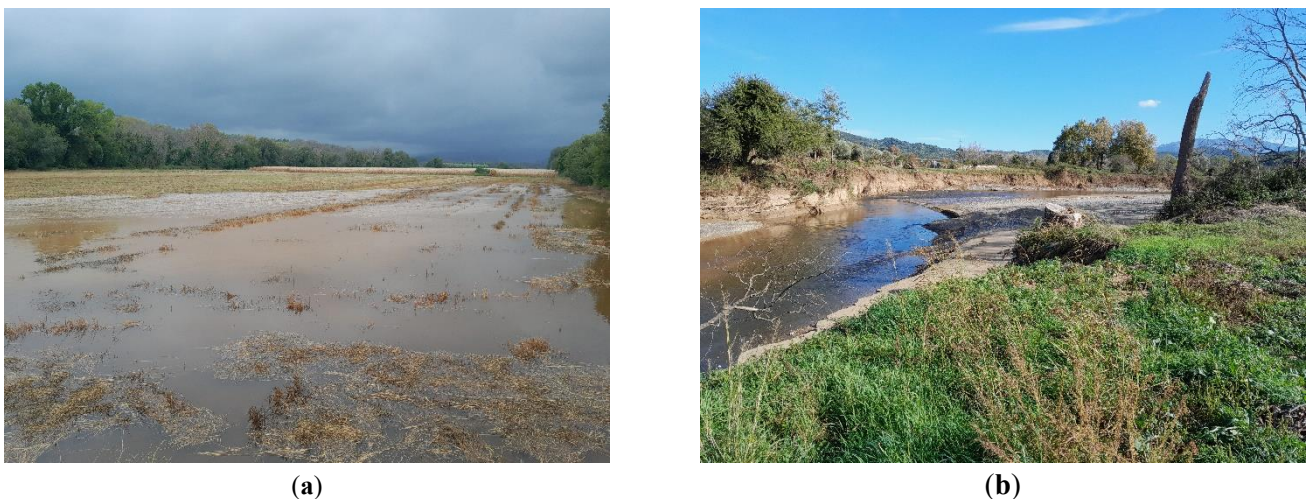
Figure 9. (a) Flood plains in Nileas River basin during storm Daniel (b) Alterations in riverbed after storm Elias.

Storms Daniel and Elias occurred in September 2023 [20] and significant rainfall was reported across many Greek regions as also documented by Copernicus [21]. Cities Limni and Istiaia recorded 216 mm of rainfall in 7 h and 140 mm of rainfall in 3.5 h respectively [22,23]. Riverbed widened by Storm Elias, leading to crop destruction (Figure 9) alterations in riverbed (Figure 9b) and the collapse of civil infrastructures and private properties (Figure 10) [20].

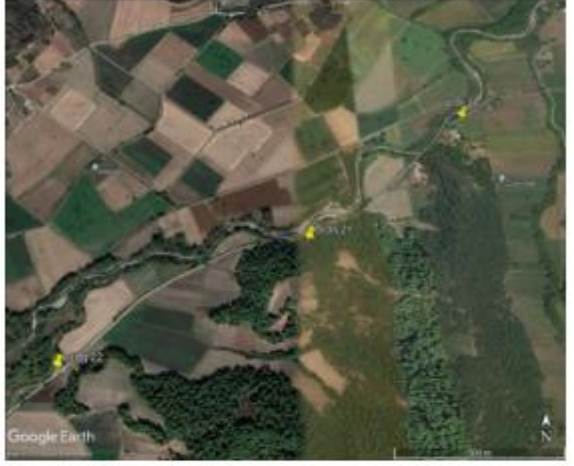
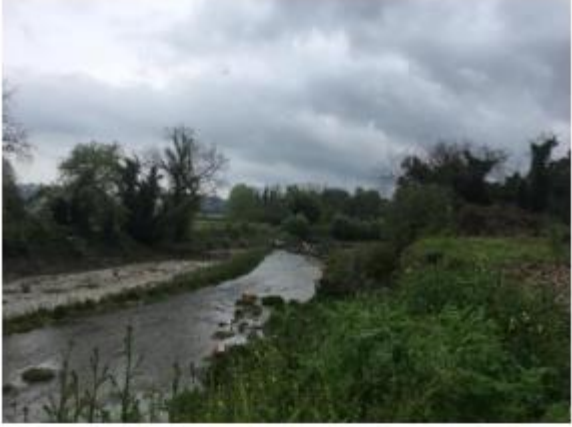
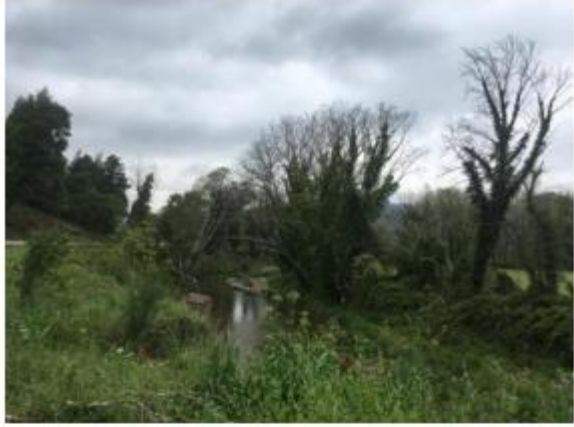
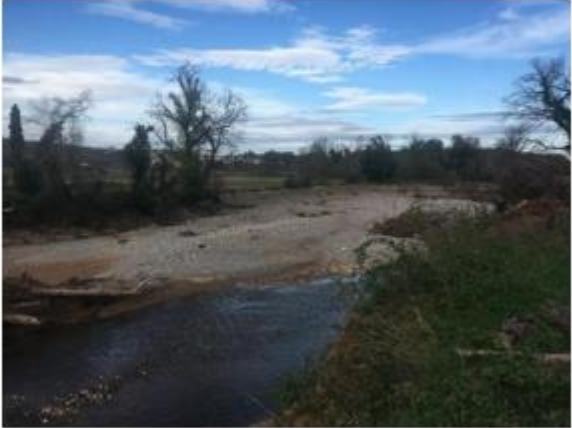
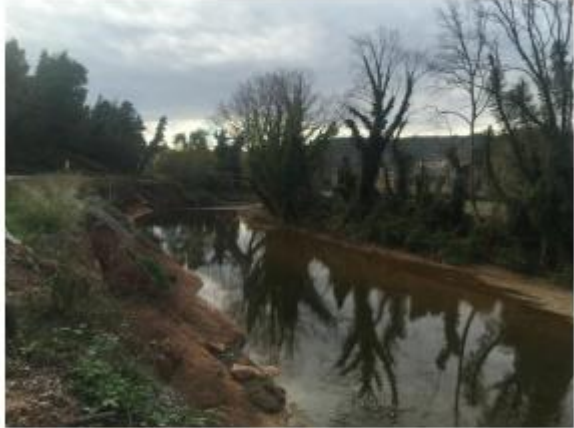
Figure 12. Example of the on-site inspection in Nileas riverbed (more analytical in Section 4 of the Supplementary Material).

Name	Landmark 21

Coordinates	38°47'52"N 23°26'26"E	
Coordinates ΕΓΣΑ '87	451269,89154031 4294197,6799047	
Notes: Important alterations of the landscape are noted		
Downstream		Upstream

- Dramatic alterations in the width of the riverbed after the flood events, especially at lower altitudes.
- Large amount of sediment in the delta of the Voudouros River.
- Change of the natural landscape both along the river and on the beach where the river flows into the sea.
- Destruction of arable land.
- Road collapses in several locations
- Changes in the roughness of the floodplain and the riverbed.
