# Fast-Track Documentation of the Alterations on the Landscape, before and after a Natural Hazard—Case Study: North Euboea Greece before and after Storms Daniel and Elias

G.-Fivos Sargentis <sup>1,\*</sup>, Konstantina Moraiti <sup>1</sup>, Ioannis Benekos <sup>2</sup>, Romanos Ioannidis <sup>1</sup> and Nikos Mamassis <sup>1</sup>

<sup>1</sup> Laboratory of Hydrology and Water Resources Development, School of Civil Engineering, National Technical University of Athens, 9, Iroon Polytechniou Str., 15772 Zografou, Greece; ntinamor1998@gmail.com (K.M.); romanos.ioannidis@gmail.com (R.I.); nikos@itia.ntua.gr (N.M.)

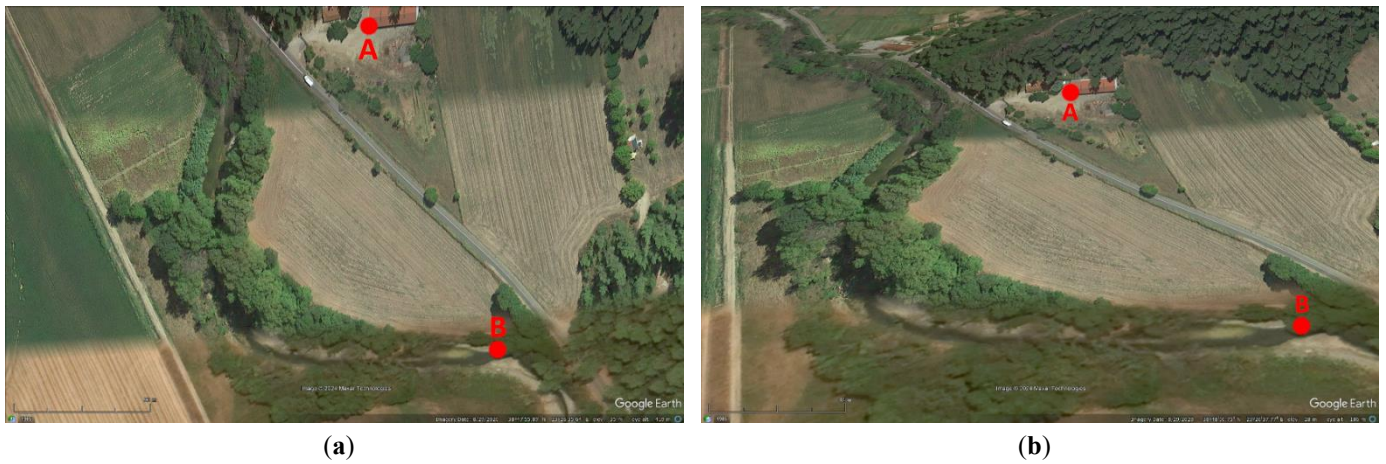
**Figure 9.** The study area in Google Earth [43], (a) horizontal view; (b) angled view. Landmarks: A:  $38^{\circ}47'59.84''$  N,  $23^{\circ}26'42.23''$  E; B:  $38^{\circ}47'57.14''$  N,  $23^{\circ}26'33.39''$  E; date: 29 August 2020.

The selected areas for the composition of 3D models are near the village Kerinthos in North Euboea [42], depicted in Figure 8, an example of the results in position 5 is depicted in Figures 9–11 and the results of positions 1–5 are depicted in the supplementary material. Figure 9 shows the area by the archive of Google Earth (before the storms Daniel and Elias) and Figures 10 and 11 show the creation of 3D models in obj file viewer and Blender, respectively, by the same areas after the storms Daniel and Elias.

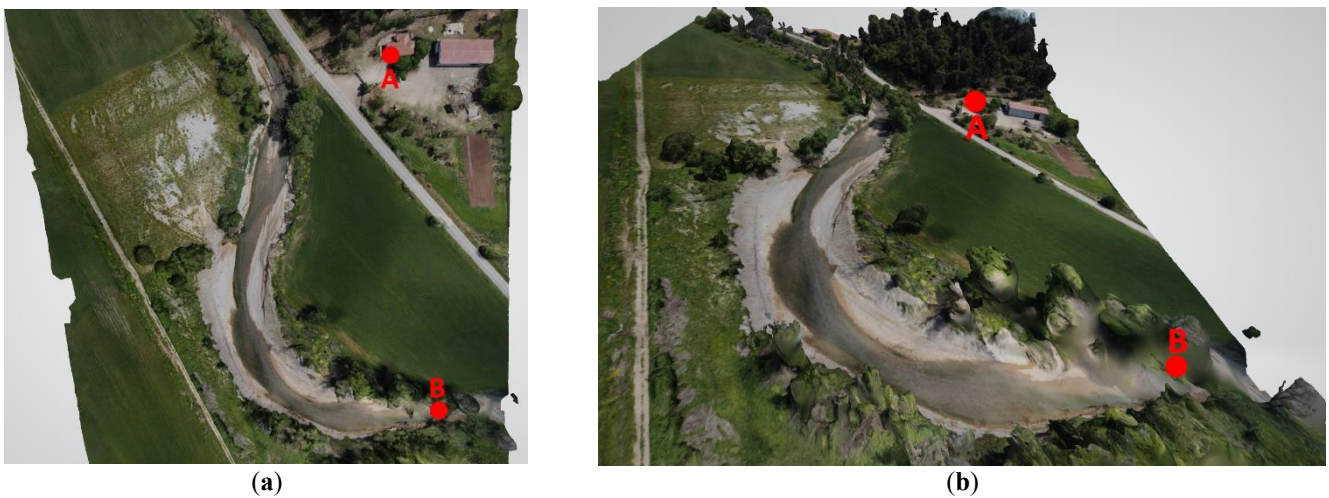
**Figure 10.** The composed 3D model in obj viewer. (a) horizontal view; (b) angled view. The landmarks A and B correspond to the landmarks in Figure 9. Date: 2 May 2024 [44].

Selected parts of the affected area were initially recorded through multiple consecutive images with a low-cost commercial drone. These photos were then processed through the online application KIRIENGINE, which uses photogrammetry to create three-dimensional models. The drone photos were uploaded to the online platform of KIRIENGINE and processed to create 3D models. Once the photos were imported, the application processed the data with photogrammetry and exported the 3D models, which enabled the comparison of similar views of the model with the affected area. The last step may also be viewed using the open-source software Blender [41]. The aforementioned procedure provides additional insight into the affected area and input for a rapid assessment, hence facilitating its study by the engineers.
