Fast-Track Documentation of the Alterations on the Landscape, before and after a Natural Hazard—Case Study: North Euboea Greece before and after Storms Daniel and Elias

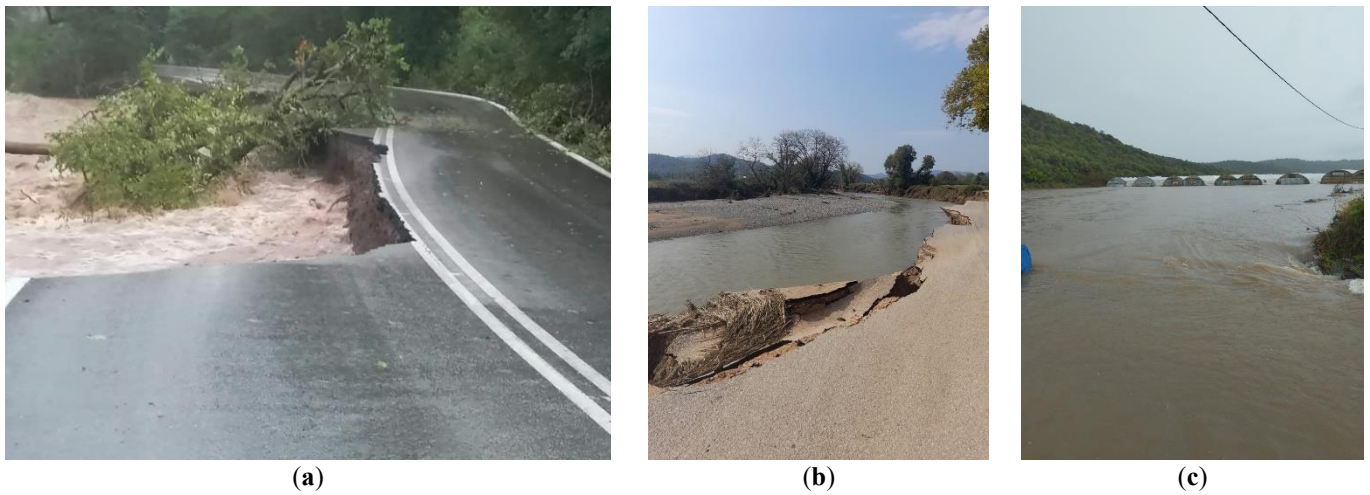
Figure 2. Failure of the infrastructures from the event of Elias storm; (**a**) Road collapse during the event; (**b**) Expand of the riverbed and nearby road collapse (**c**) Flooded greenhouses.

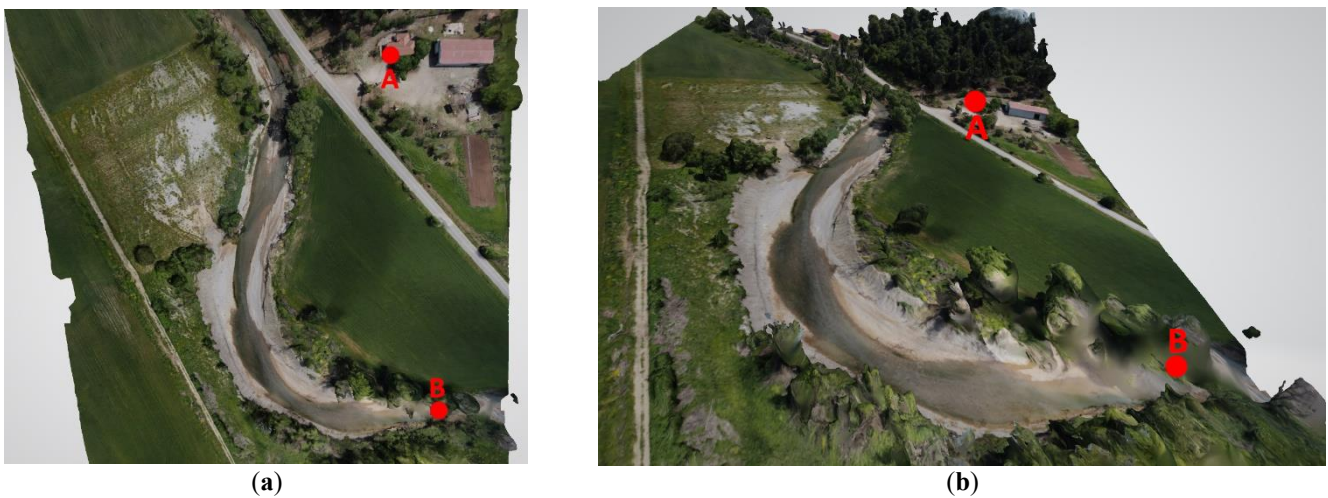
Figure 10. The composed 3D model in obj viewer. (**a**) horizontal view; (**b**) angled view. The landmarks A and B correspond to the landmarks in Figure 10. Date: 2 May 2024 [44].

- Even though storms Daniel and Elias were more intense than the Zorbas storm, the floodplain was smaller. The riverbed had significantly widened during the Daniel and Elias storms.

- Significant alterations were found within the riverbed width, especially at the lower altitudes of the basin. This is associated with the pre-existing conditions of local fauna and, in particular, the problems local plane trees face due to disease.

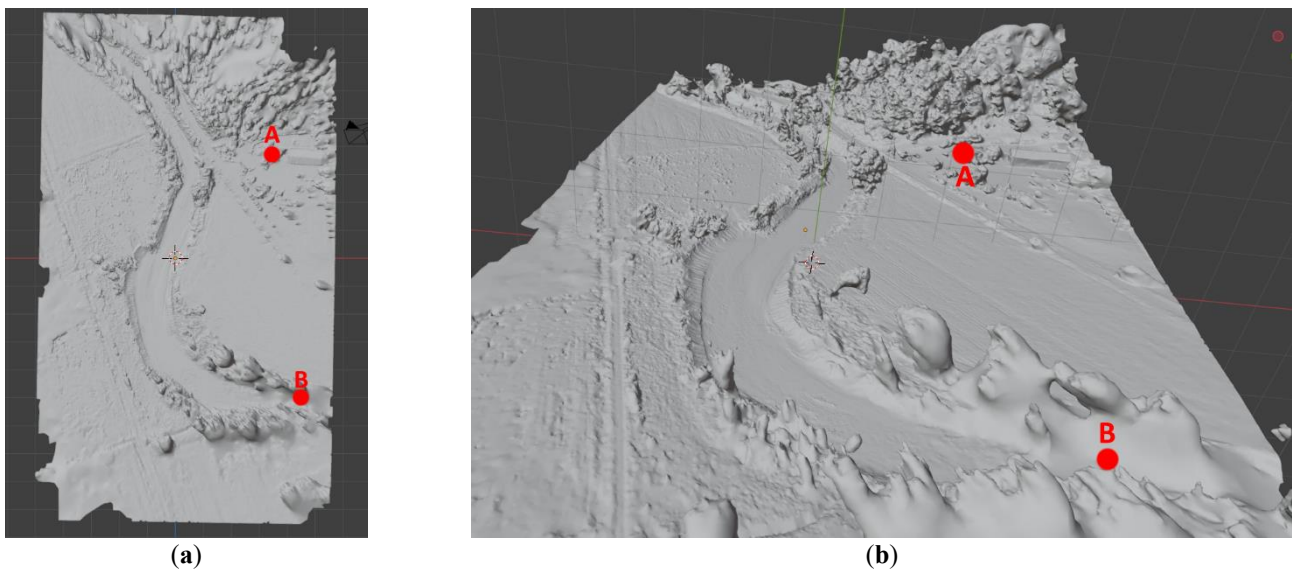
Figure 11. The composed 3D model in obj file in software Blender. The landmarks A and B correspond to the landmarks in Figure 10. (**a**) horizontal view; (**b**) angled view.
